**Flood Control Project Maintenance
Levee Inspections**
LMA District Cover Sheet
Spring 2017 Levee Inspection Results

Reclamation District No. 0404 Boggs

Spring 2017 Levee Inspection Results

Waterway			Bank	Unit Miles
Unit No. 01 San Joaquin River			Right	2.35
	Spring (March - May)	Summer (June - August)	(September - November) Fall	Winter (December - February)
Unit Maintenance Rating (Fall Only)				
Date of Inspection	4/6/2017 - 4/6/2017			
DWR Inspector	Richard Willoughby			
Accompanied By	Bob Winter KSN

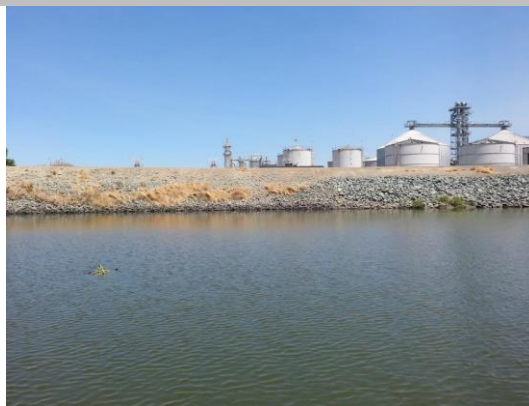
Photo 1 of 2 : SP_2017_RD0404_305_32_20170316_00021.jpg

LM Start	0.34	Rating **	U	Issue No.	32
LM End	0.34	Issue Type +	Ma	Location *	WS
Category	Supplemental			GPS Latitude/Longitude	
				Start	End
Item	DWR Erosion Survey			37.939190 °	37.939190 °
				-121.338280 °	-121.338280 °
DWR ID	DWR_RD0404_01_s_2017_32				
Comment Code					
Inspector Comment					
07/25/2016: No significant change observed.					
06/24/2015: No significant change observed.					
06/19/2014: No significant change observed.					
08/13/2013: No significant change at this site.					
08/7/2012: The erosion is next to a repaired site and approximately 400 feet downstream of a river bend. There are broken concretes at the upper levee slope, but not visible at the levee toe or lower slope. Likely the protection concrete blocks have been washed away. [2016 Site ID:RD0404U01RM41.11]

Front view of the site.

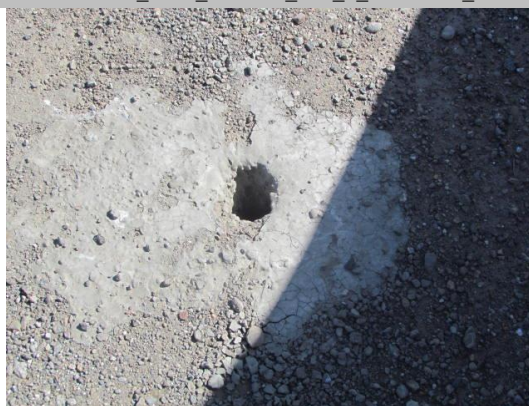
Photo 2 of 4 : SP_2017_RD0404_305_5_20170316_00005.jpg

LM Start	0.43	Rating **	A/W	Issue No.	5 (cont)	
LM End	0.43	Issue Type +	Ma	Location *	CR	
Category	Earthen Levee			GPS Latitude/Longitude		
				Start		End
Item	Animal Control			37.939635 °		37.939635 °
				-121.339063 °		-121.339063 °
DWR ID	DWR_RD0404_01_s_2013_5					
Comment Code						
A3 : No rodents visible, but rodent burrows visible; need to backfill and compact or grout burrows.						
Inspector Comment						
District grouted hole, and the deficiency still exist.

Looking at partially grouted rodent hole on levee crown

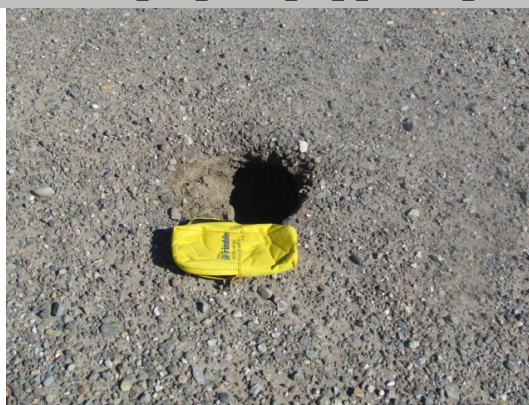
Photo 3 of 4 : SP_2017_RD0404_305_5_20170316_00006.jpg

Looking at rodent hole on levee crown.

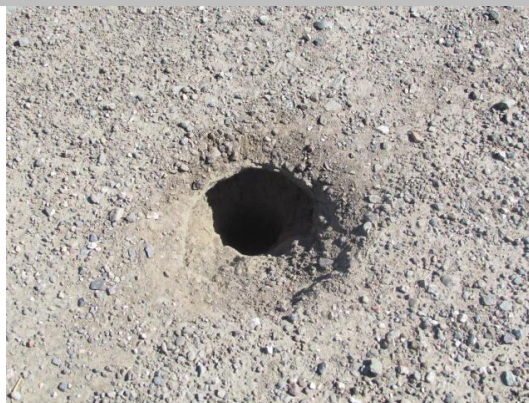
Photo 4 of 4 : SP_2017_RD0404_305_5_20170316_00007.jpg

Looking at one of several rodent holes on levee crown.

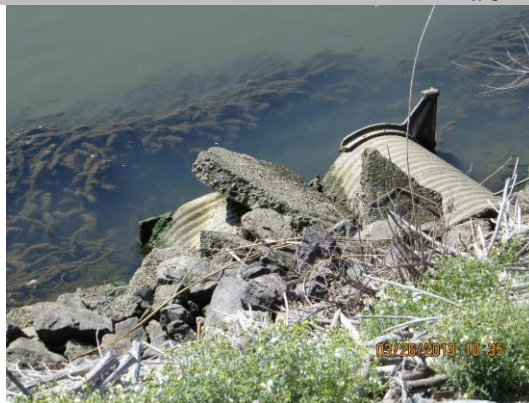
Photo 1 of 3 : UCIP_SP_2017_51163_20082.jpg

LM Start	0.48	Rating **	U	Issue No.	103
LM End	0.48	Issue Type +	En	Location *	CR
Category	Supplemental			GPS Latitude/Longitude	
				Start	End
Item	DWR UCIP Field Study			37.939640 °	37.939640 °
				-121.338175 °	-121.338175 °
DWR ID					
Comment Code					
Inspector Comment					
FS_ID:51163 DS_ID:22968 EP_NO: N/A Repair Type: Urgent Crossing Status: Found UCIP Comments: 11/29/2016 Flap gates still missing. Pipe open on WS. Could not locate on LS. (K. Fazel - UCIP)03/26/2013 Flap gate missing from WS toe. (P. Amatya - DWR) FIELD_STRUCT_DESC: 1 of 2: 36-inch corrugated metal drainage pipe, approximately 18 feet below the crown. Pipes may not fully penetrate levee as they do not daylight on the landside (LS). Pipes are field discovered with no mention in any reference. FS Date: 11/29/2016

WS- two CM pipes with damaged flap gates

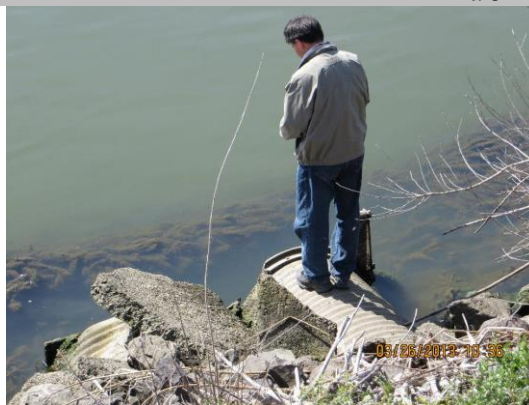
Photo 2 of 3 : UCIP_SP_2017_51163_20081.jpg

WS- left CM pipe with missing flap gate

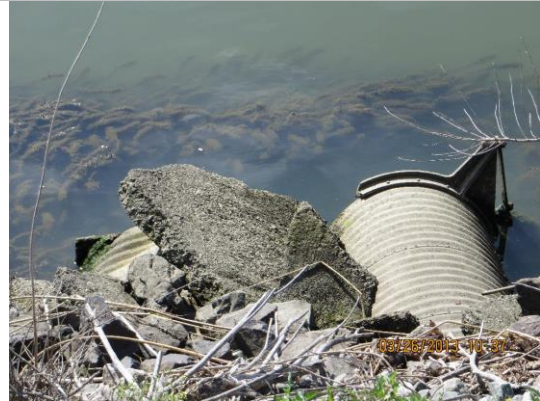
Photo 3 of 3 : UCIP_SP_2017_51163_20080.jpg

WS- closer look at left CM pipe with missing flap gate

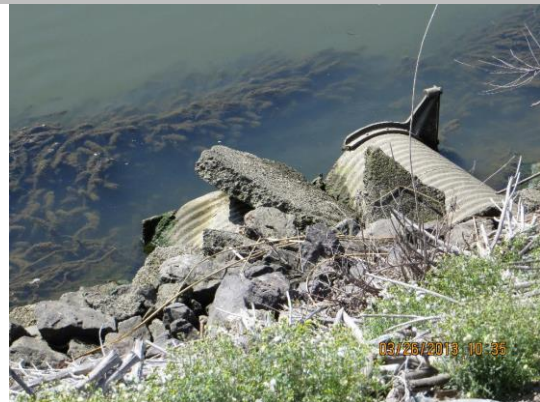
Photo 1 of 3 : UCIP_SP_2017_51164_20086.jpg

LM Start	0.48	Rating **	U	Issue No.	104
LM End	0.48	Issue Type +	En	Location *	CR
Category	Supplemental			GPS Latitude/Longitude	
				Start	End
Item	DWR UCIP Field Study			37.939640 °	37.939640 °
				-121.338175 °	-121.338175 °
DWR ID					
Comment Code					
Inspector Comment					
FS_ID:51164 DS_ID:22969 EP_NO: N/A Repair Type: Urgent Crossing Status: Found UCIP Comments: 11/29/2016 Flap gate appears to be either missing or broken. Pipes submerged on WS with concrete block on one pipe during inspection. No pipes found on LS. (K. Fazel - UCIP)03/29/2013 Pipe has broken flap gate. (P. Amatya - DWR) FIELD_STRUCT_DESC: 2 of 2: 36-inch corrugated metal drainage pipe, approximately 18 feet below the crown. Pipes may not fully penetrate levee as they do not daylight on the landside (LS). Pipes are field discovered with no mention in any reference. FS Date: 11/29/2016

WS- two CM pipes with damaged flap gates

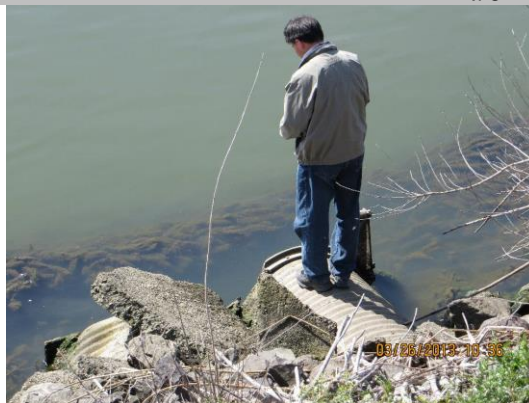
Photo 2 of 3 : UCIP_SP_2017_51164_20085.jpg

WS- right CM pipe with damaged flap gate

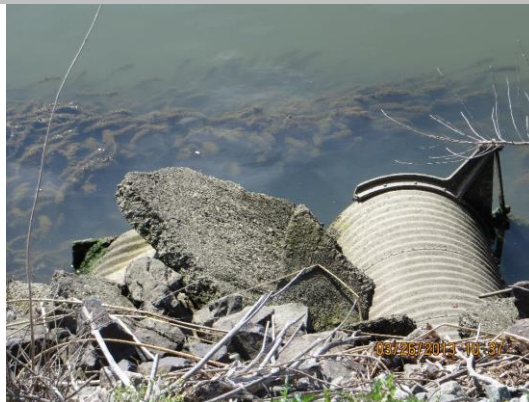
Photo 3 of 3 : UCIP_SP_2017_51164_20084.jpg

WS- closer view of right CM pipe with damaged flap gate

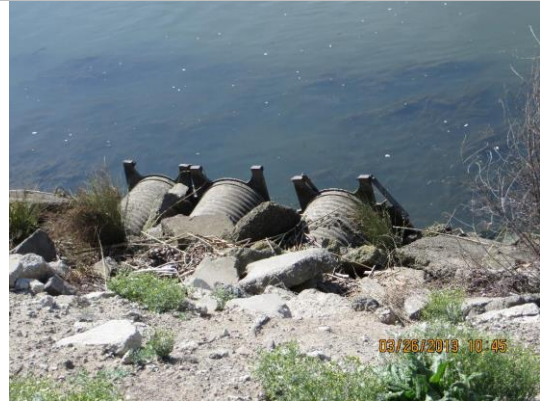
Photo 3 of 3 : UCIP_SP_2017_51168_20042.jpg

LM Start	0.65	Rating **	M	Issue No.	105 (cont)	
LM End	0.65	Issue Type +	En	Location *	CR	
Category	Supplemental			GPS Latitude/Longitude		
				Start	End	
Item	DWR UCIP Field Study			37.938670 °	37.938670 °	
				-121.335397 °	-121.335397 °	
DWR ID						
Comment Code						
Inspector Comment						
FS_ID:51168 DS_ID:17952 EP_NO: N/A Repair Type: Non-Urgent Crossing Status: Found UCIP Comments: Steel intake structure on landside of the levee. FIELD_STRUCT_DESC: 2 of 3: 30-inch corrugated metal drainage pipe through the levee, 22 feet below the crown. Flap gates on the waterside (WS) ends. Steel intake structure on the landside (LS). [Additional Reference(s): DWR Levee Log, 2006]. FS Date: 3/26/2013

WS- CM pipes with damaged flap gates

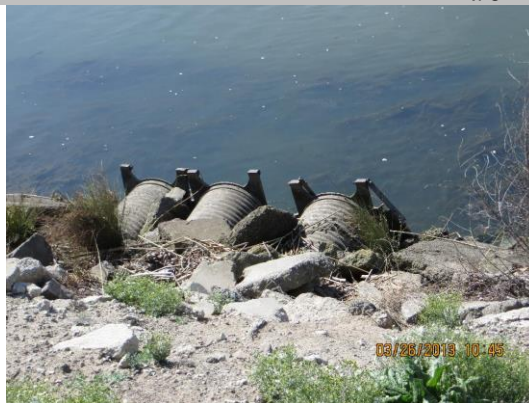
Photo 2 of 3 : UCIP_SP_2017_51166_20046.jpg

Comment Code					
Inspector Comment					
FS_ID:51166 DS_ID:18811 EP_NO: N/A Repair Type: Urgent Crossing Status: Found UCIP Comments: 12/13/2016 Since previous inspector and 2006 Levee Log cite damage to flap gate, I have upgraded this crossing from Non-Urgent to Urgent. Flap gates need to be in good working condition. (K. Fazel - UCIP)03/26/2013 Steel intake structure on LS. (P. Amatya - DWR)12/26/2006 Landward end filled with dirt. Middle flap gate missing and right flap gate broken as of 1/24/07. (DWR Levee Log) FIELD_STRUCT_DESC: 3 of 3: 30-inch corrugated metal drainage pipe through the levee, 22 feet below the crown. Flap gates on the waterside (WS) ends. Steel intake structure on the landside (LS). [Additional Reference(s): DWR Levee Log, 2006]. FS Date: 3/26/2013

WS- CM pipes and damaged flap gates

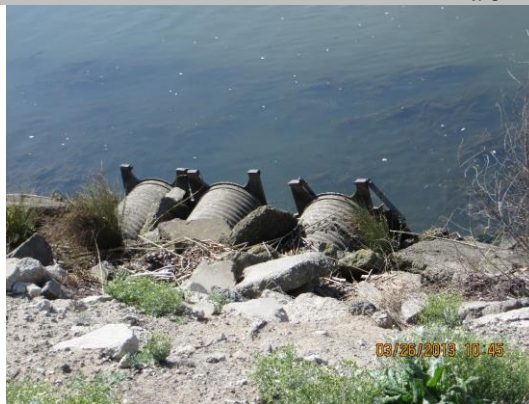
Photo 2 of 3 : UCIP_SP_2017_51167_20053.jpg

Comment Code					
Inspector Comment					
FS_ID:51167					
DS_ID:18810					
EP_NO: N/A					
Repair Type: Urgent					
Crossing Status: Found					
UCIP Comments: 12/13/2016 Since previous inspector and 2006 Levee Log cite damage to flap gate, I have upgraded this crossing from Non-Urgent to Urgent. Flap gates need to be in good working condition. (K. Fazel - UCIP)03/26/2013 Steel intake structure on LS. (P. Amatya - DWR)12/26/2006 Landward end filled with dirt. Middle flap gate missing and right flap gate broken as of 1/24/07. (DWR Levee Log)					
FIELD_STRUCT_DESC: 1 of 3: 30-inch corrugated metal drainage pipe through the levee, 22 feet below the crown. Flap gates on the waterside (WS) ends. Steel intake structure on the landside (LS). [Additional Reference(s): DWR Levee Log, 2006].					
FS Date: 3/26/2013

WS- CM pipes with damaged flap gates

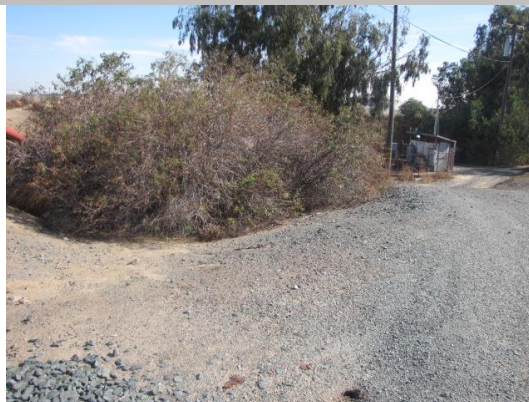
Photo 1 of 1 : SP_2017_RD0404_305_7_20170316_00008.jpg

LM Start	0.75	Rating **	M	Issue No.	7
LM End	0.75	Issue Type +	Ma	Location *	LS
Category	Earthen Levee			GPS Latitude/Longitude	
				Start	End
Item	Vegetation			37.937758 °	37.937758 °
				-121.334149 °	-121.334149 °
DWR ID	DWR_RD0404_01_s_2012_7				
Comment Code					
V4 : Elderberries are blocking visibility and flood fight capability.					
Inspector Comment

Looking southeast at elderberry on landside slope.

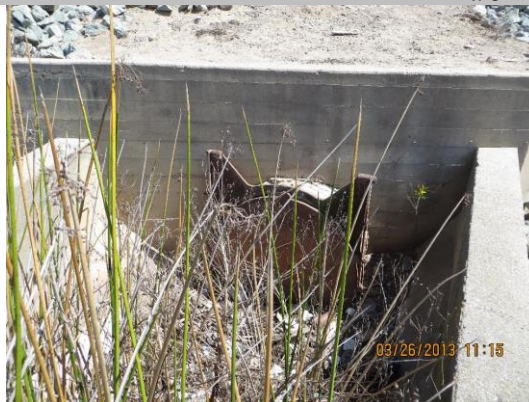
Photo 2 of 3 : UCIP_SP_2017_51169_19961.jpg

Comment Code					
Inspector Comment					
FS_ID:51169					
DS_ID:17945					
EP_NO: N/A					
Repair Type: Urgent					
Crossing Status: Found					
UCIP Comments: 11/29/2016 Flap gate still buried with sediment on WS. Requires clearing. (K. Fazel - UCIP)03/26/2013 Partially burried flap gate (P. Amatya - DWR)					
FIELD_STRUCT_DESC: 42-inch corrugated metal drainage pipe, 18 feet below the crown. Flap gate, concrete headwall and spillway on the waterside (WS). Pumphouse on the landside (LS). Abandoned concrete headwall, power pole, and two wooden piles found on the LS.					
[Additional Reference(s): DWR Levee Log, 2006. USACE San Joaquin O&M Manual 001, March 1963 (HLM 0.78)]. Pipe likely belongs to the City of Stockton.					
FS Date: 11/29/2016

WS- Debris and vegetation blocking CM drainage pipe

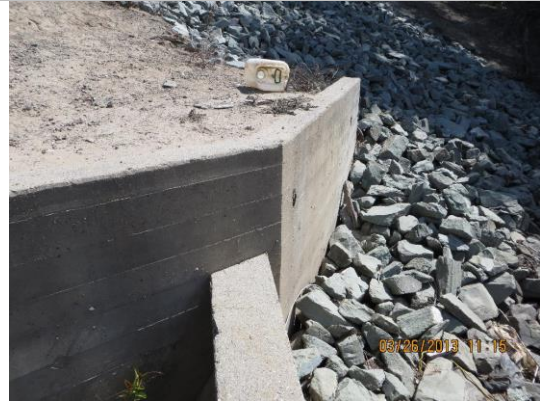
Photo 3 of 3 : UCIP_SP_2017_51169_19960.jpg

WS- slightly tilted outlet structure

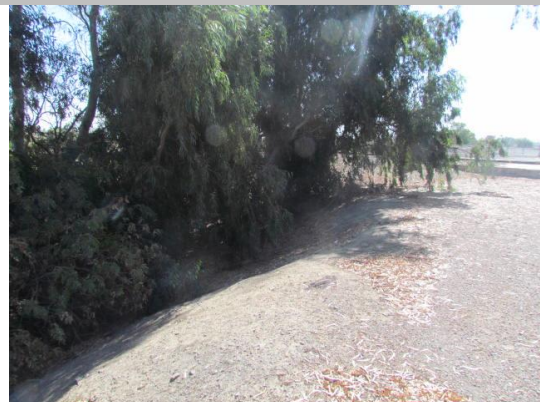
Photo 1 of 1 : SP_2017_RD0404_305_8_20170316_00009.jpg

LM Start	0.78	Rating **	M	Issue No.	8
LM End	0.78	Issue Type +	Ma	Location *	LS
Category	Earthen Levee			GPS Latitude/Longitude	
				Start	End
Item	Trim / Thin Trees			37.937395 °	37.937395 °
				-121.333883 °	-121.333883 °
DWR ID	DWR_RD0404_01_s_2013_8				
Comment Code					
T1 : Trim trees to at least five feet above ground level.					
Inspector Comment					
Trees are blocking view of the slope.

Looking southeast at dense trees on landward slope and toe.

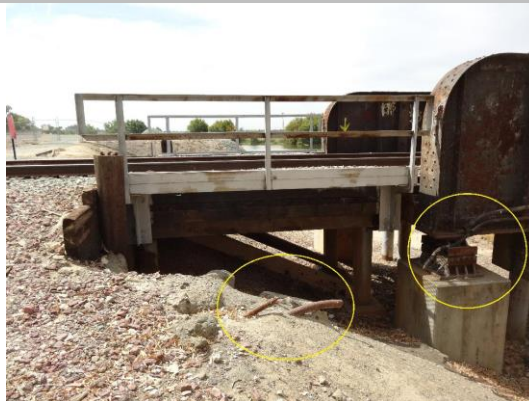
Photo 1 of 3 : UCIP_SP_2017_46810_74753.jpg

LM Start	0.79	Rating **	M	Issue No.	109
LM End	0.79	Issue Type +	En	Location *	LS
Category	Supplemental			GPS Latitude/Longitude	
				Start	End
Item	DWR UCIP Field Study			37.937212 °	37.937212 °
				-121.333762 °	-121.333762 °
DWR ID					
Comment Code					
Inspector Comment					
FS_ID:46810 DS_ID:17946 EP_NO: N/A Repair Type: Non-Urgent Crossing Status: Found UCIP Comments: Appears abandoned; if so should be done so properly. FIELD_STRUCT_DESC: Underground telephone cable through levee and across channel. Non-operational. FS Date: 8/4/2015

WS view looking south: conduits penetrating levee slope now disconnected with those attached to bridge

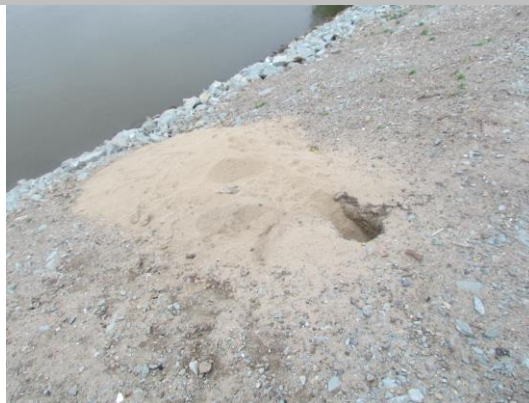
Photo 2 of 2 : SP_2017_RD0404_305_42_20170407_00071.jpg

Looking northwest at large animal hole (den) on waterward shoulder.

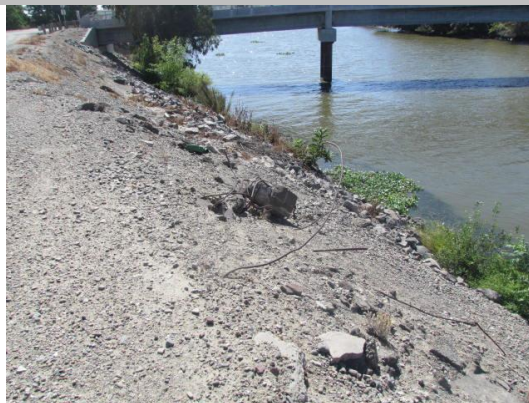
Photo 1 of 1 : SP_2017_RD0404_305_4_20170316_00003.jpg

Looking southwest at concrete rubble with rebar on waterward slope.

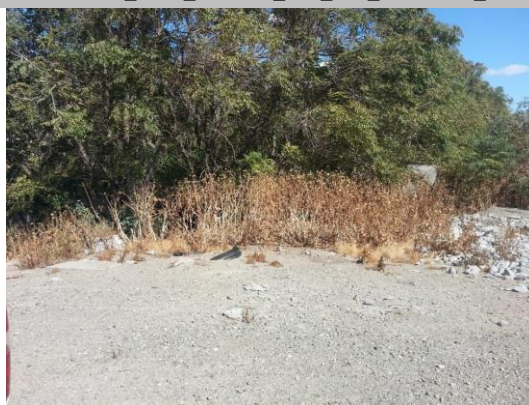
Photo 1 of 2 : SP_2017_RD0404_305_101_20170316_00030.jpg

Looking east at dense vegetation on landward slope. (Fall 2016)

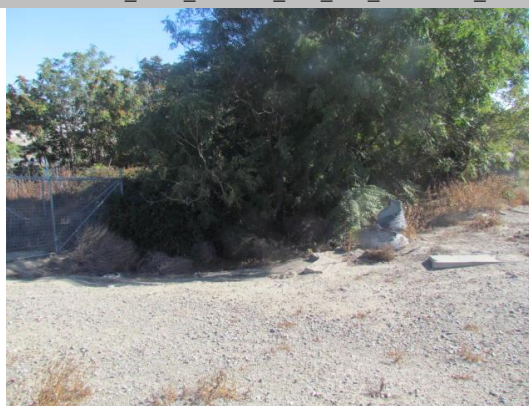
Photo 2 of 2 : SP_2017_RD0404_305_101_20170316_00031.jpg

Looking southeast at overhanging trees on landside slope. (Fall 2015)

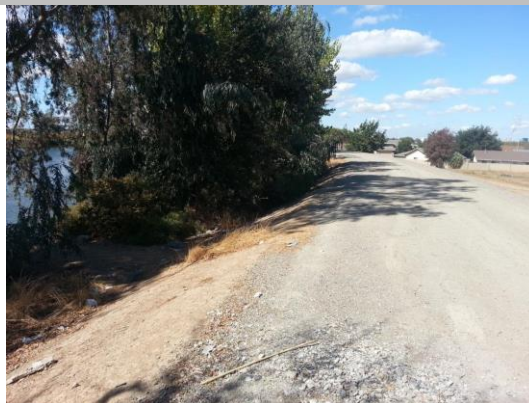
Photo 1 of 1 : SP_2017_RD0404_305_100_20170316_00029.jpg

Looking northwest at untrimmed trees on waterward slope.

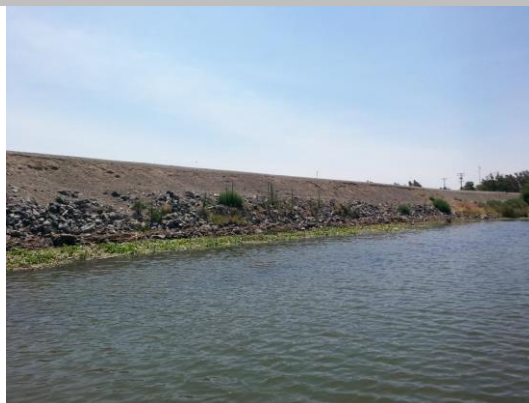
Photo 1 of 2 : SP_2017_RD0404_305_41_20170316_00027.jpg

LM Start	1.44	Rating **	M	Issue No.	41
LM End	1.46	Issue Type +	Ma	Location *	WS
Category	Supplemental			GPS Latitude/Longitude	
				Start	End
Item	DWR Erosion Survey			37.930450 °	37.930450 °
				-121.327450 °	-121.327450 °
DWR ID	DWR_RD0404_01_s_2017_41				
Comment Code					
Inspector Comment					
07/25/2016: No significant change observed.					
06/24/2015: No significant change observed.					
06/19/2014: A series of scarp erosions have been found on the lower levee slope and at the levee toe. [2016 Site ID:RD0404U01RM42.02]

Downstream view of the erosion.

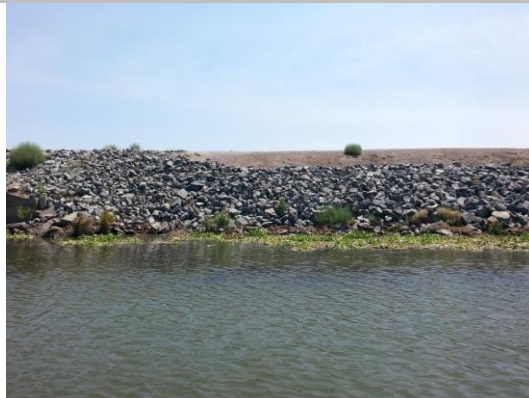
Photo 2 of 2 : SP_2017_RD0404_305_41_20170316_00028.jpg

Close view of the erosion. The upstream end of the site is protected by riprap revetment.

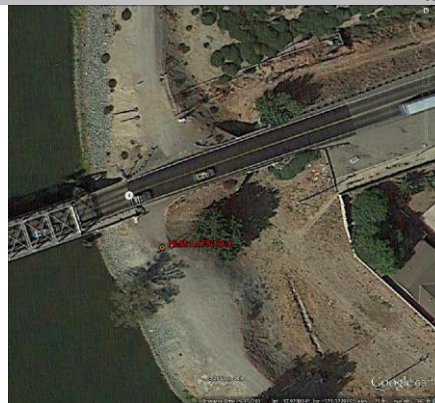
Photo 1 of 1 : UCIP_SP_2017_12386_20062.jpg

Aerial Photo @HLM=1.5791: No sign posts/markers found.

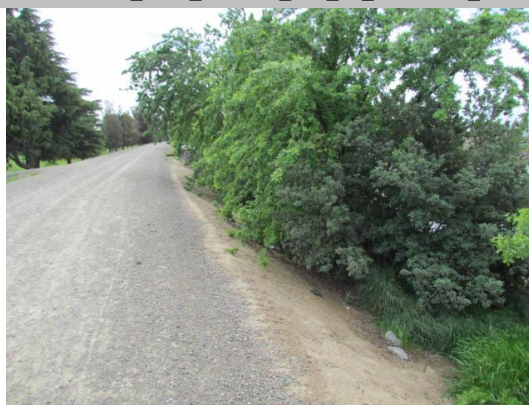
Photo 2 of 2 : SP_2017_RD0404_305_29_20170316_00019.jpg

Looking south at dense vegetation on waterward slope.

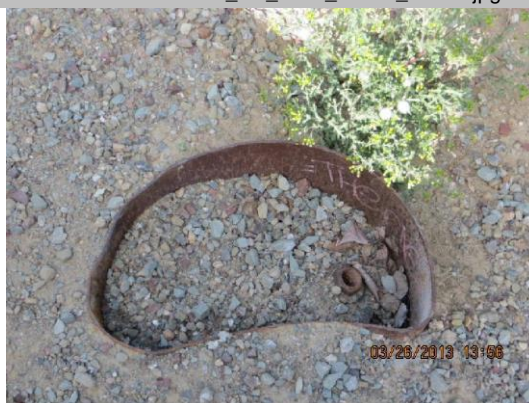
Photo 3 of 3 : UCIP_SP_2017_40797_20071.jpg

LS- damaged and obstructed siphon breaker on levee shoulder.

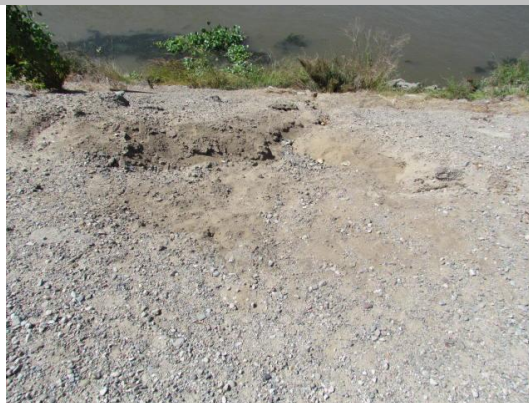
Photo 1 of 2 : SP_2017_RD0404_305_16_20170316_00011.jpg

Looking west at slope damage due to foot traffic.

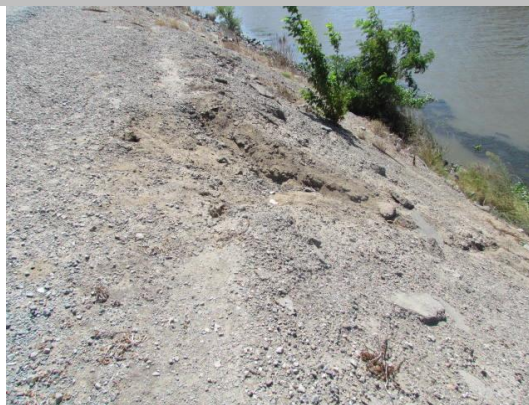
Photo 2 of 2 : SP_2017_RD0404_305_16_20170316_00012.jpg

Looking southwest at slope damage due to foot traffic.

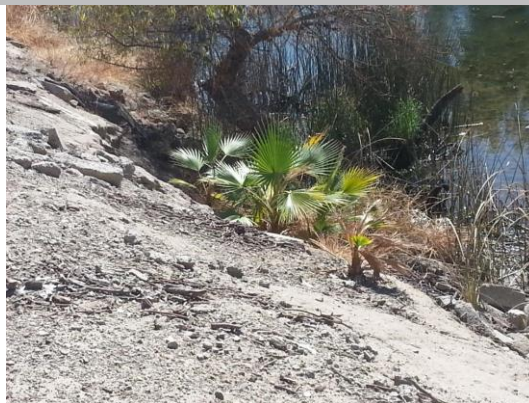
Photo 1 of 1 : SP_2017_RD0404_306_14_20170316_00003.jpg

Looking southeast at erosion on waterward slope.

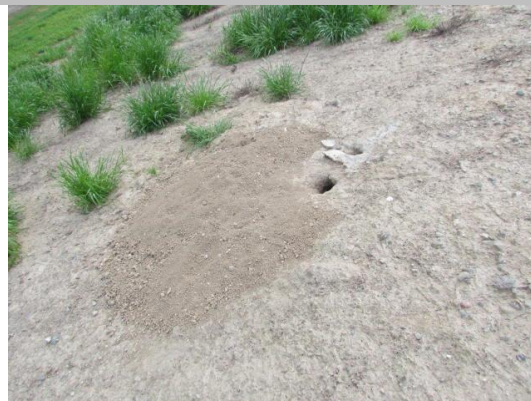
Photo 1 of 2 : SP_2017_RD0404_306_21_20170316_00009.jpg

Looking northeast at large rodent hole on landward slope.

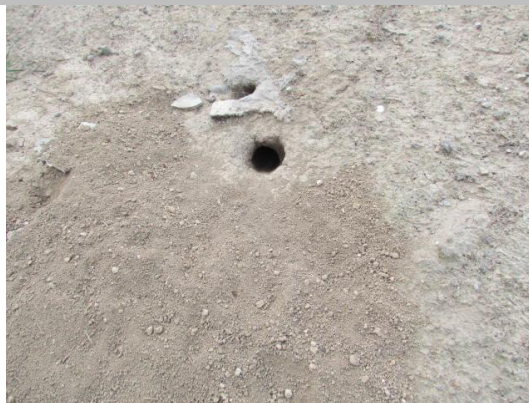
Photo 2 of 2 : SP_2017_RD0404_306_21_20170316_00010.jpg

Looking east at large rodent hole on landward slope.

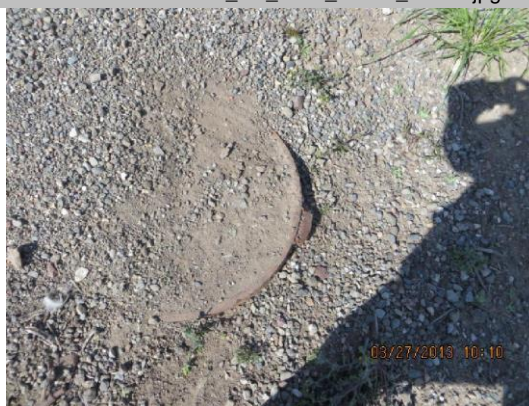
Photo 2 of 3 : UCIP_SP_2017_10908_18181.jpg

WS- damaged, obstructed and buried siphon breaker

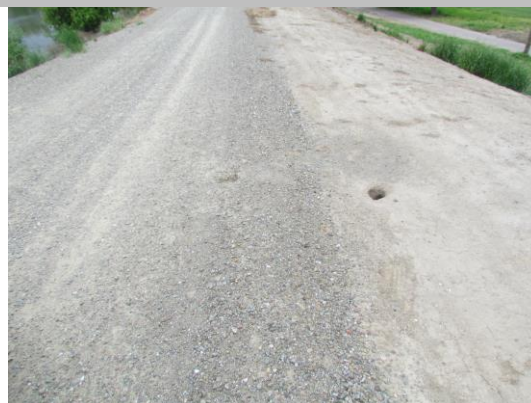
Photo 1 of 3 : SP_2017_RD0404_306_20_20170407_00031.jpg

Looking northeast at rodent hole on landward shoulder.

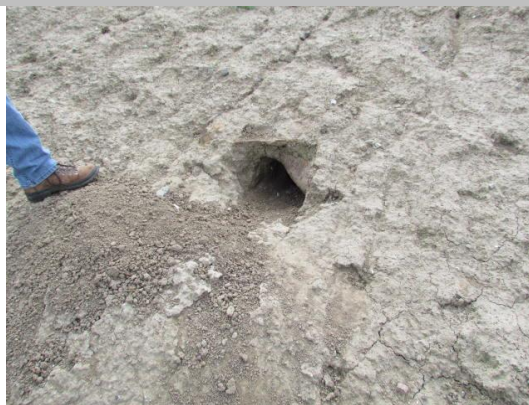
Photo 3 of 3 : SP_2017_RD0404_306_20_20170316_00008.jpg

Looking at rodent hole on landward slope.

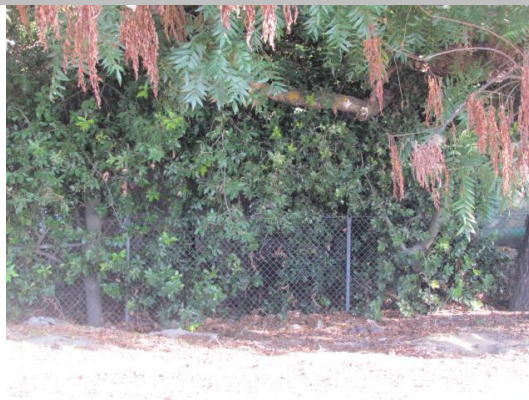
Photo 1 of 4 : SP_2017_RD0404_306_67_20170316_00011.jpg

Looking northeast at dense vegetation inside fenced area near pump station on landside toe.

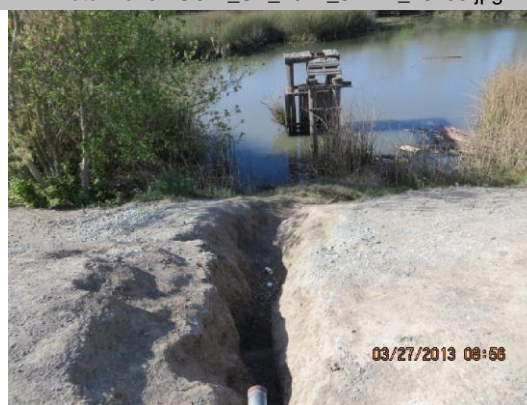
Photo 2 of 3 : UCIP_SP_2017_51171_18133.jpg

WS- soil erosion and gully formation due to leaky pipe

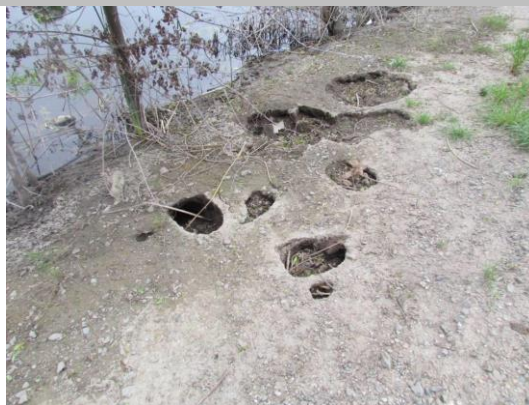
Photo 2 of 2 : SP_2017_RD0404_306_19_20170407_00035.jpg

Looking north at several sink holes at waterward toe.
